# WHY'D THAT COME BACK?

## Application: 1997-2004 Mitsubishi Montero /Montero Sport with V-6 Engine

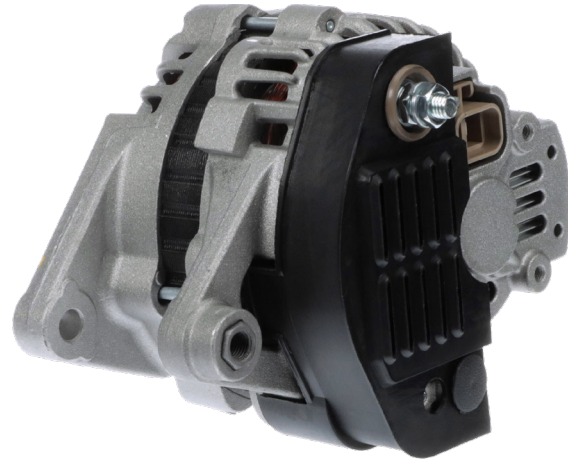
- ▶ **Symptom:** Repeat alternator failure.
- ▶ **Cause:** Oil leaking from the front, passenger camshaft seal side. The oil is drawn through the alternator as the vehicle is running, causing premature failure.
- ▶ **The Solution:** This alternator comes with a specially designed oil drip guard, but steps should be taken to repair the oil leak.

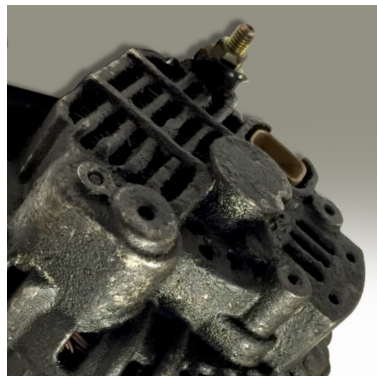
Close up view of an oil-soaked alternator.

A leaking valve cover gasket, camshaft seal, a power steering pump, or power steering hose will contaminate the alternator with oil causing it to short out and fail.

The oil is drawn through the alternator as the vehicle is running, causing the premature failure.

This guard will help prolong the life of the alternator, but this is not a cure and the leak will need to be fixed.

Replace the camshaft seal(s) as necessary. If the camshaft seals leak, the timing belt may need to be replaced as well.
