**Application: 1997-2004 Mitsubishi
Montero/Montero Sport with V-6 Engine**

**Repeat alternator failure is not the fault of the alternator,
and may be the result of an oil leak.**

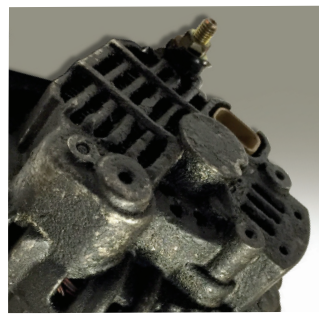
Close up view of an oil-soaked alternator.

A leaking valve cover gasket, camshaft seal, a power steering pump, or power steering hose will contaminate the alternator with oil causing it to short out and fail.

The oil is drawn through the alternator as the vehicle is running, causing the premature failure.

This guard will help prolong the life of the alternator, but this is not a cure and the leak will need to be fixed.

Replace the camshaft seal(s) as necessary. If the camshaft seals leak, the timing belt may need to be replaced as well.
