Fault P0299 May Not Be Caused By The Turbocharger

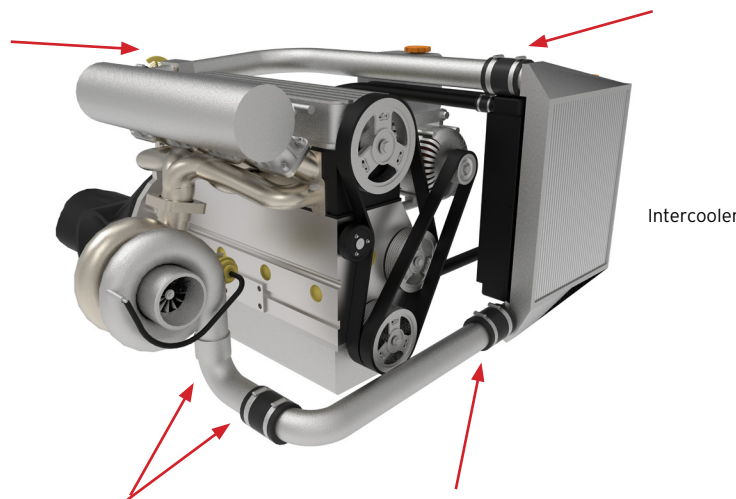
Carefully inspect all duct work for air leaks, loose connections, and damage which will affect boost and could cause the P0299 fault code.
