Application: 2002-2010 Ford Explorer, Explorer Sport Trac, Lincoln Aviator, and Mercury Mountaineer.

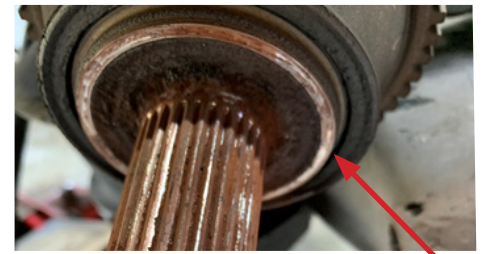
Notice the shiny area on the CV Housing which indicates touching/contact with the Hub Bearing outer race and Bearing Retaining Clip.

If the Hub is not fully seated when pressed into the Bearing during installation, the Drive Axle/CV Joint can contact the outer Bearing Race and Retaining Ring, causing a rubbing noise when driving, which can lead to the misdiagnosis of a defective Bearing. When pressing in the Bearing and Hub, a Bearing Press with a minimum of 20-ton capacity should be used to ensure the Bearing and Hub are correctly installed and fully seated. The correct press adaptors and press support plates should be used to properly press and support the Bearing, Hub, and Knuckle assembly during installation. Make sure to completely seat the Hub when pressing it into the Bearing. Torque all mounting bolts and the Drive Axle Nut to proper specifications with a Torque Wrench during final assembly on the vehicle.

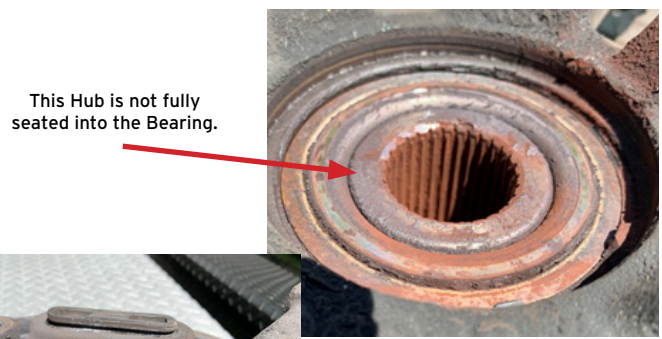
This Hub is not fully seated into the Bearing.

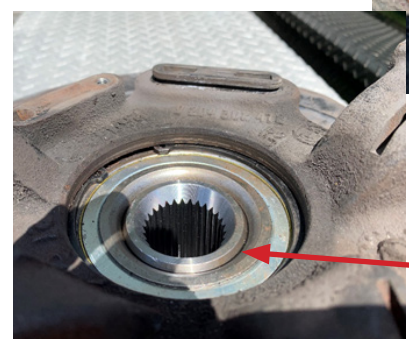
This Hub is fully seated after being pressed into the Bearing properly.
