**Application: 1997-2004 Mitsubishi
Montero/Montero Sport with V-6 Engine**

**Repeat alternator failure is not the fault of the alternator,
and may be the result of an oil leak.**

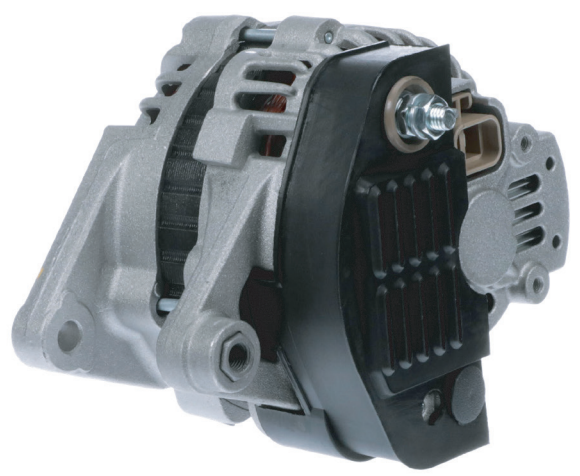
- ▶ **Symptom:**
Repeat alternator failure.
- ▶ **Cause:**
Oil leaking from the front, passenger camshaft seal side. The oil is drawn through the alternator as the vehicle is running, causing premature failure.
- ▶ **The Solution:**
This alternator comes with a specially designed oil drip guard, but steps should be taken to repair the oil leak.

When a Mitsubishi Montero, or Montero Sport with a V-6 engine, from the years 1997-2004 suffers from a charging system failure, the problem may be caused by an oil-soaked alternator.

A leaking valve cover gasket, camshaft seal, a power steering pump, or power steering hose will contaminate the alternator with oil causing it to short out and fail.

The oil is drawn through the alternator as the vehicle is running, causing the premature failure.

This guard will help prolong the life of the alternator, but this is not a cure and the leak will need to be fixed.

Replace the camshaft seal(s) as necessary. If the camshaft seals leak, the timing belt may need to be replaced as well.
