Application: 2002-2010 Ford Explorer, Explorer Sport Trac, Lincoln Aviator, and Mercury Mountaineer.

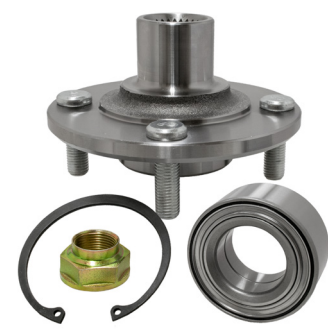
Notice the shiny area on the CV Housing which indicates touching/contact with the Hub Bearing outer race and Bearing Retaining Clip.

If the Hub is not fully seated when pressed into the Bearing during installation, the Drive Axle/CV Joint can contact the outer Bearing Race and Retaining Ring, causing a rubbing noise when driving, which can lead to the misdiagnosis of a defective Bearing. When pressing in the Bearing and Hub, a Bearing Press with a minimum of 20-ton capacity should be used to ensure the Bearing and Hub are correctly installed and fully seated. The correct press adaptors and press support plates should be used to properly press and support the Bearing, Hub, and Knuckle assembly during installation. Make sure to completely seat the Hub when pressing it into the Bearing. Torque all mounting bolts and the Drive Axle Nut to proper specifications with a Torque Wrench during final assembly on the vehicle.
