**Application: 2001-2004 Nissan Xterra and Frontier
with 3.3L V6 engines**

- ▶ **Symptom:**
Starter Failure Caused By an Oil Soaked Starter.
- ▶ **Cause:**
A leaking valve cover gasket.
- ▶ **The Solution:**
Replace leaking valve cover gaskets prior to installing
a replacement starter.

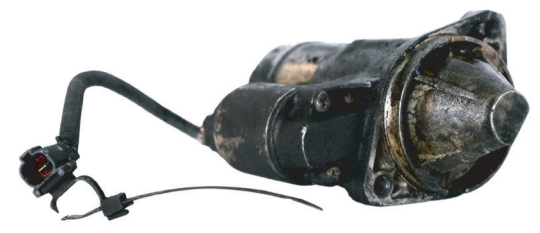
Oil Soaked Starter

Oil Damaged Starter Brush Assembly

Oil Damaged Starter Armature

Replacing the valve cover gasket is an inexpensive and easy fix

If your 2001- 2004 Nissan Xterra or Frontier with a 3.3L V-6 engine is suffering from a failed starter, it may be caused by a leaking valve cover gasket seal. These vehicles are known for valve cover gasket leaks. The passenger side leak will run down the back of the engine, enter the starter and severely shorten its lifespan.

Oil leaking into the starter will eventually destroy the brushes and the armature causing premature failure of the starter. To address this problem of leaking oil, the valve cover gasket will need to be replaced.
